GEOENVIRONMENTAL PROBLEMS DUE TO HARMONY LANDSLIDE IN GARHWAL HIMALAYA, UTTARAKHAND, INDIA

R. Anbalagan¹, Sujata Parida^{2*}

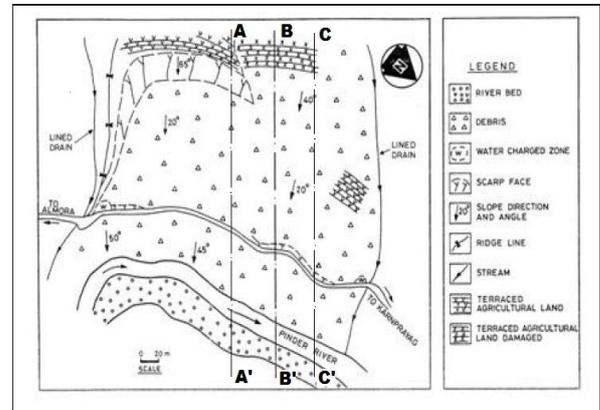
Fig.2. Geological map of the slide area

There are no rock exposures present within the Harmony landslide area. The entire area is blanketed by debris material derived from an ancient landslide. As such it consists of assorted materials ranging from clay to big boulders, which have been obtained from the adjoining rock exposures (Fig. 2).

From the three sections viz. Sec – 1 (A-A'), Sec – 2 (B-B') and Sec – 3 (C-C') (Fig. 2) drawn across the slide area, the slide has been identified as rotational type of failure. The slide is observed as still active on the basis of observations and discussion with local people. The loose slope debris, mixed with fine soil (clay to sand size fraction), derived from the in-situ rock exposures of Phyllites and Phyllitic Quartzites are mixed with fine soil (clay to sand size fraction). In-situ bed rock may be present at the deeper levels. It is an active slide, which gets activated almost every year during rains. The slope materials of the slide area are mostly debris having low strength, derived from the in-situ rock exposures of Phyllites and Phyllitic Quartzites. Loose material consisting of rock blocks is mixed with fine soil (clay to sand size fraction) and in-situ bed rock may be present at the deeper levels.
